講演会 「《海を返せ》《パフォーマンス・スコア》調査と修復」

2. 《海を返せ》《パフォーマンス・スコア》修理経過報告

Lecture “Investigation and Restoration: *Give Our Sea Back and Performance Score*”

2. Progress Report: Repair of *Give Our Sea Back* and *Performance Score*

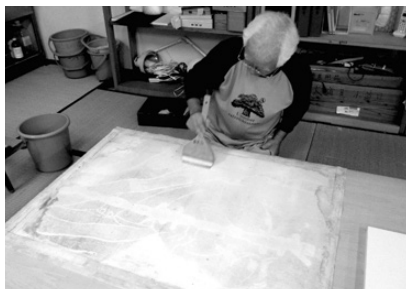
Fig.3

*3

N：浮け貼りは、基本的に下の板から浮き上がらせる方法です。何枚も貼ってありますが、この1枚の紙の周囲5ミリにしか糊はつけていません。それを重ねながら、5、6cmずつ、天地も左右も重ねながら貼っていきます。この作品は下の基底材も中性紙を貼ったものに変えてあります。さらに用心のために浮け貼りをし、下の基底材と直接触れ合わないようにします。これは、伝統的な日本の屏風やふすまの貼り方ですが、今回の修理もこの方法を応用しました。

- ・パネルと本紙の間に刃物を差し込みながら、本紙を傷つけないように作品を取り外した。
- ・四周のコラージュした箇所や、支持体からの浮きは正麩糊で補強した。
- ・四周の脆弱化した箇所には裏面より岐阜県長谷川聡製楮紙と生麩糊で補強を施した。
- ・新調したパネルに富山県五箇山宮本友信製楮紙で浮け締めをかけ、乾燥させた。(Fig.3) *3
