講演会 「《海を返せ》《パフォーマンス・スコア》調査と修復」

2. 《海を返せ》《パフォーマンス・スコア》修理経過報告

Lecture “Investigation and Restoration: *Give Our Sea Back and Performance Score*”

2. Progress Report: Repair of *Give Our Sea Back* and *Performance Score*

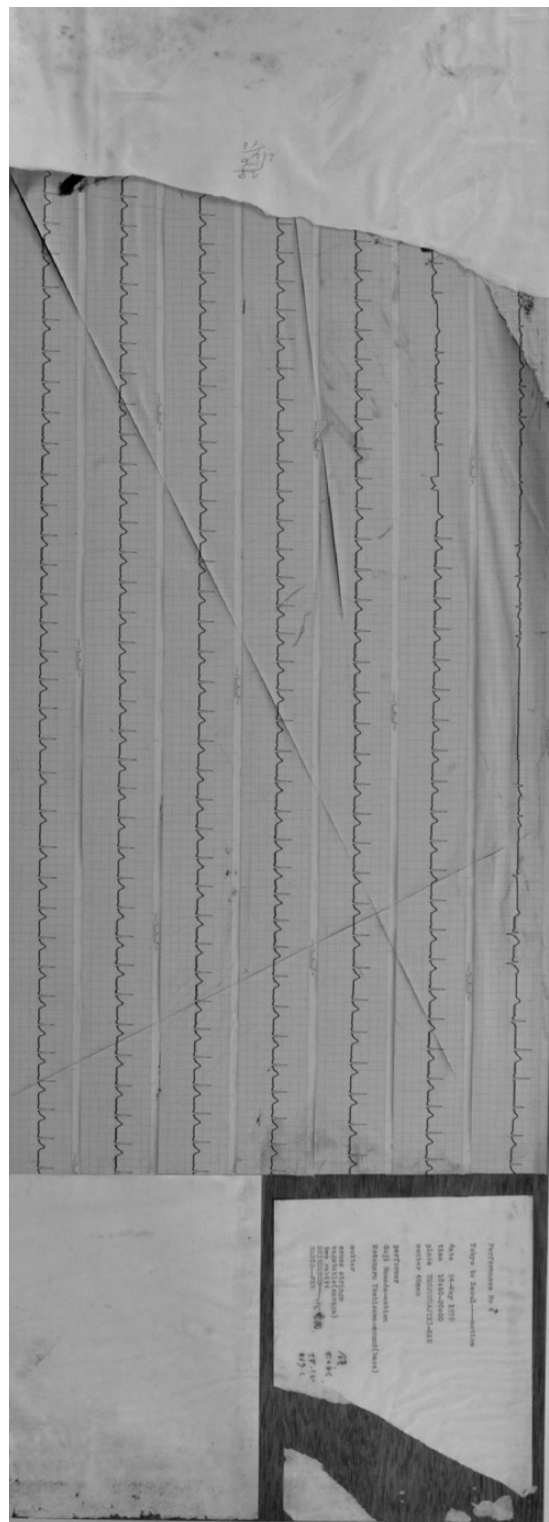
ベニヤに貼られている。上層は、シルクスクリーンでイメージが刷られた用紙で粘着性の高いもので一部接着されている。下層は、用紙、感熱紙等がパネルに直接貼られている。上層の本紙は汚損し、下部には焼けた様に欠失している。下層の用紙上のサインのインクが上層の用紙に滲んでいる。また、調査により、下部の汚損は黴によるものであり、下層の用紙にも影響が出ていることが判明した。

- ・作品と同質の感熱紙でサンプル実験を行った。
- ・作品をパネルから慎重に取り外した。
- ・インク書きやタイプ打ちの文字は牛皮和膠 10% で滲み止めを施した。
- ・感熱紙以外はエタノール 70% を用い、念のため殺菌を行った。
- ・2 点は作品に表養生を施し、精製水で汚れを吸い出し、岐阜県美濃市長谷川聡製楮紙と生麩糊で裏打ちを施した。
- ・乾燥後、中性紙の台紙に作品を元通り生麩糊で張り込んだ。その際、重なり等を考慮し、裏面に回して張り込みを行った。(Fig.7)
- ・感熱紙は、下部は欠損部の形と居りに岐阜県美濃市長谷川聡製楮紙をくり抜き、喰い裂き部分を生麩糊で接着した。
- ・上部は隠れる部分のみ岐阜県美濃市長谷川聡製楮紙を同様に取り付け、その部分で台紙に取り付けた。^{*6}
- ・中性紙の台紙裏面に岐阜県美濃市長谷川聡製楮紙と生麩糊でヒンジをつけ、切り込みを入れたハニカムボードにヒンジを通し、裏面で接着した。^{*7}
- ・新調した額装を装着した。
- ・写真撮影を行い、修理報告書を作成した。
